# PUBLIC ROADS

JANUARY 1937

# EXPERIMENTAL BITUMINOUS TREATMENT OF SANDY-SOIL ROADS

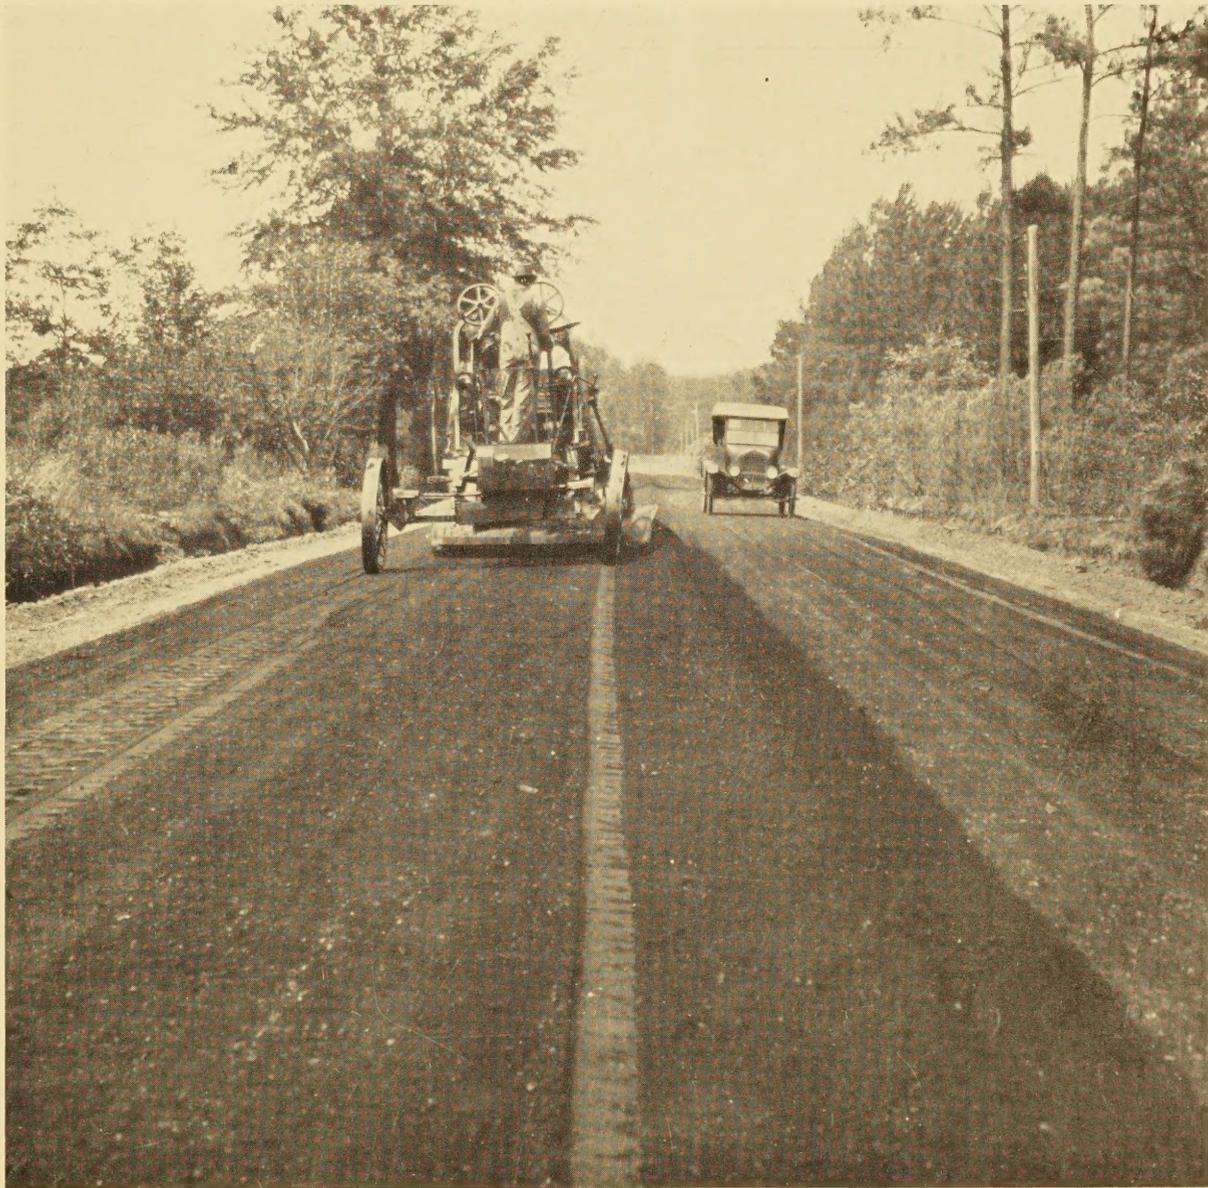
MIXING OPERATIONS ON A BITUMINIOUS EXPERIMENTAL ROAD IN SOUTH CAROLINA

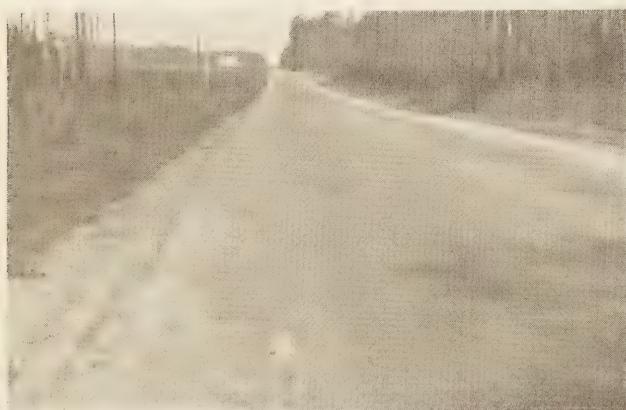
FIGURE 6.—APPEARANCE OF EXPERIMENT 7-B AT STATION 898 SEVEN YEARS AFTER CONSTRUCTION AND 3 YEARS AFTER THE ONLY SURFACE TREATMENT IT HAS RECEIVED.

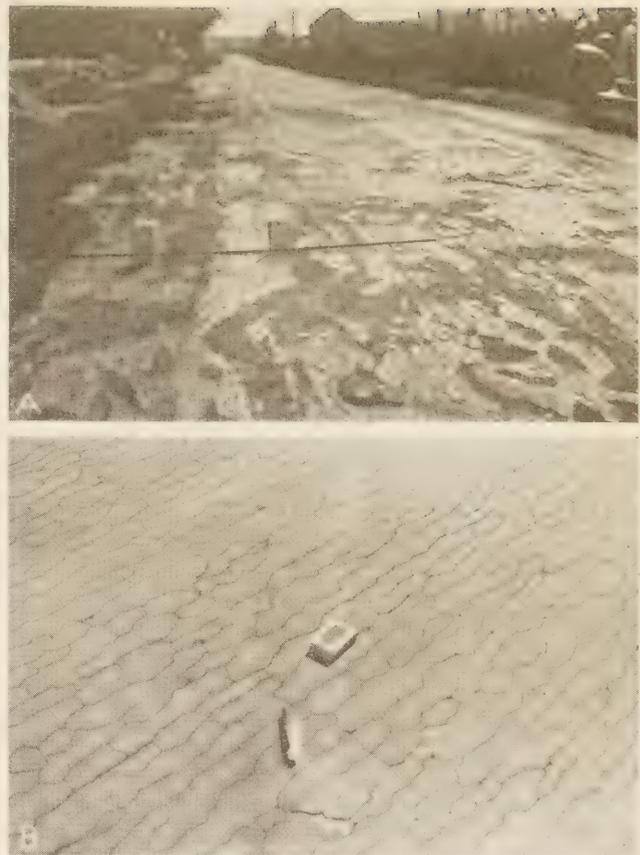
FIGURE 11.—INADEQUATE DRAINAGE CONTRIBUTED TO BASE FAILURE ON THESE EXPERIMENTAL SECTIONS. A, BOTH BASE AND SURFACE FAILED ON EXPERIMENT 2, SECTIONS C AND D. SAND WAS USED WITH A COLD-APPLICATION MATERIAL FOR SURFACE TREATMENT, RESULTING IN A RICH, PLASTIC MIXTURE. B, BADLY CRACKED AREA ON EXPERIMENT 3, CAUSED BY A PLASTIC SUBGRADE.

Figures 9-B and 11-A illustrate the unsatisfactory surface conditions that existed on these sections during the period when the wearing surfaces were composed of sand and cold-application bitumen. They also illustrate the unsatisfactory drainage conditions existing at the time the sections were built and during their early life.

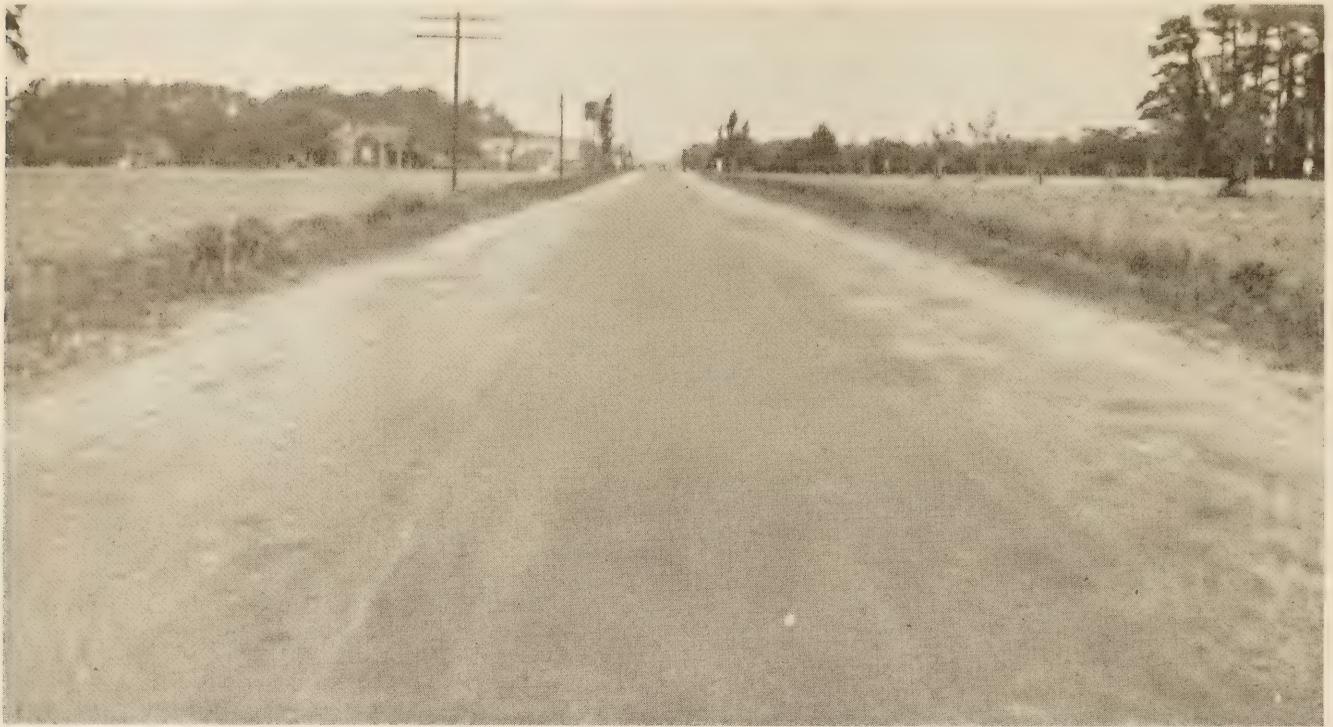
FIGURE 12.—VIEW OF EXPERIMENT 8 TAKEN 4 YEARS AFTER CONSTRUCTION. THIS IS TYPICAL OF THE APPEARANCE AND CONDITION IT HAS RETAINED SINCE CONSTRUCTION.

Experiment 8, a thin, surface-treated section on a well-drained, plastic, A-2 soil, was considerably better than the poorly drained sections of experiments 3 and 4-B, although on the latter the bituminous mats were 2 inches and 3 inches thick originally.

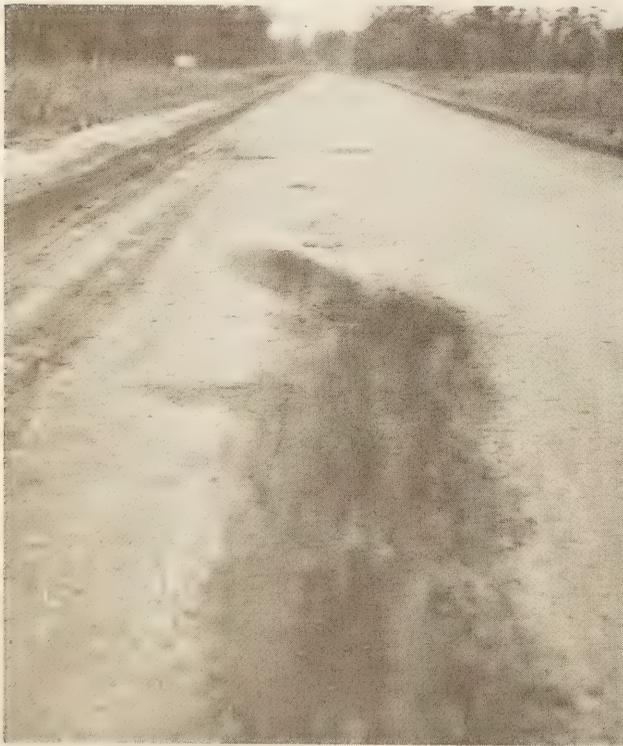
FIGURE 13.—POOR DRAINAGE RESULTED IN THE UNSATISFACTORY CONDITION OF THIS AREA OF EXPERIMENT 3 NEAR STATION 363. ANALYSES OF MAT AND SUBGRADE FROM THIS AREA ARE GIVEN IN TABLE 7.

1 Condition shown in figure 10-B.  
 2 Condition shown in figure 10-A.  
 3 Condition shown by figure 14 and 15.  
 4 Condition shown by figure 13.  
 5 Field specimens tested as received.  
 6 Data for new sand-oil mat built on old surface in 1933.  
 7 Data for old surface prior to 1933.  
 8 Under direct compression of 3,000 pounds per square inch.  
 9 Mix heated in oven for 5 hours at 163° C. (325° F.) lost 1.42 percent by weight, equivalent to 18.44 percent of its bitumen content.  
 10 Samples taken at station 436.  
 11 Insufficient material.

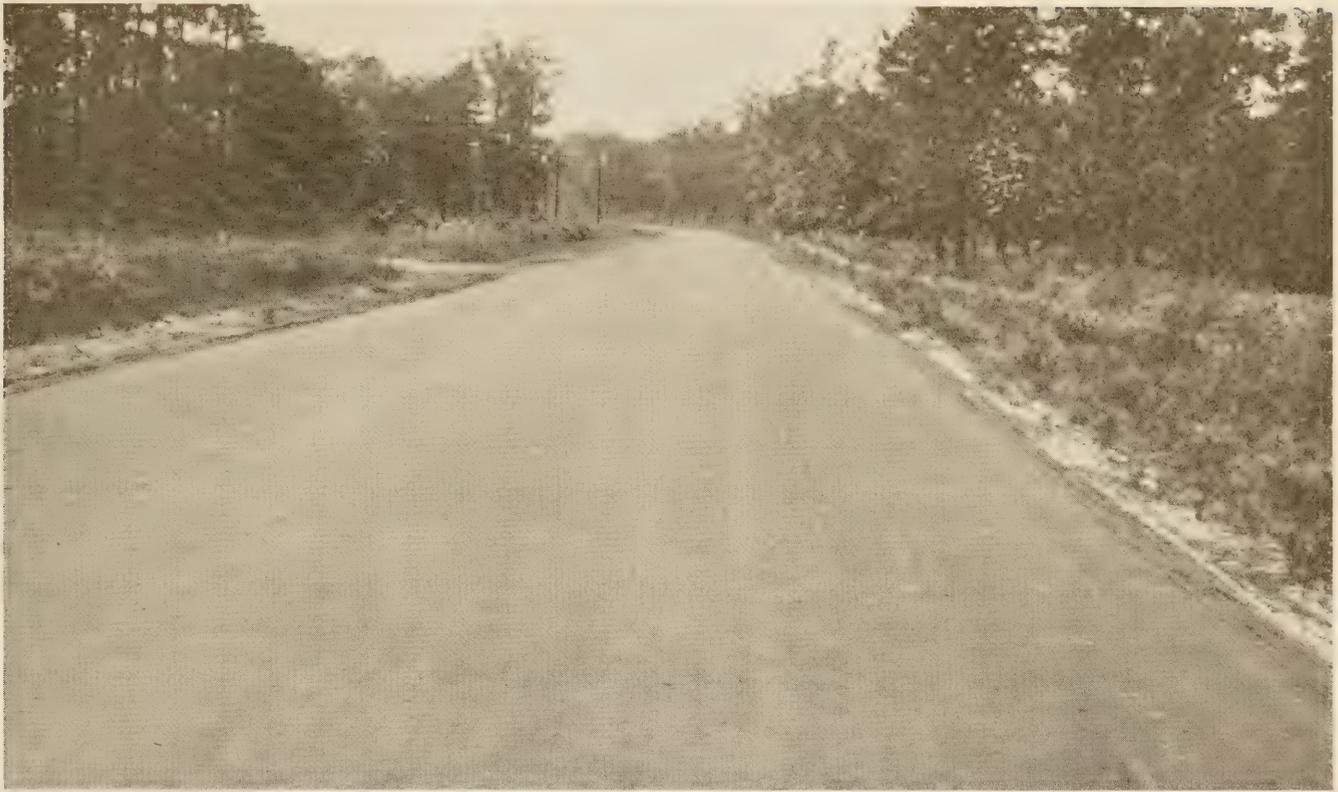
FIGURE 14.—GENERAL VIEW OF EXPERIMENT 3 AT STATION 353, SHOWING THE USUAL CONDITION OF MOST OF THIS EXPERIMENTAL SECTION. ANALYSES OF BITUMINOUS MAT AND OF SUBGRADE ARE GIVEN IN TABLE 7.

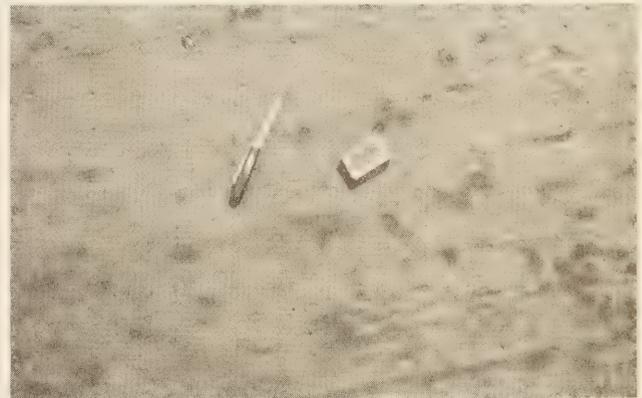
FIGURE 15.—ILLUSTRATION OF THE CLOSED TEXTURE CHARACTERISTIC OF MOST OF EXPERIMENT 3. ANALYSES OF MAT AND OF UNDERLYING SUBGRADE AT STATION 353 ARE GIVEN IN TABLE 7.
